# ***GALLIPOLIS LOCKS AND DAM***

**FOUNDATION REPORT**

**VOLUME 4 PHOTOGRAPHS**

**CONSTRUCTION OF TWO PARALLEL LOCKS AND CANAL**

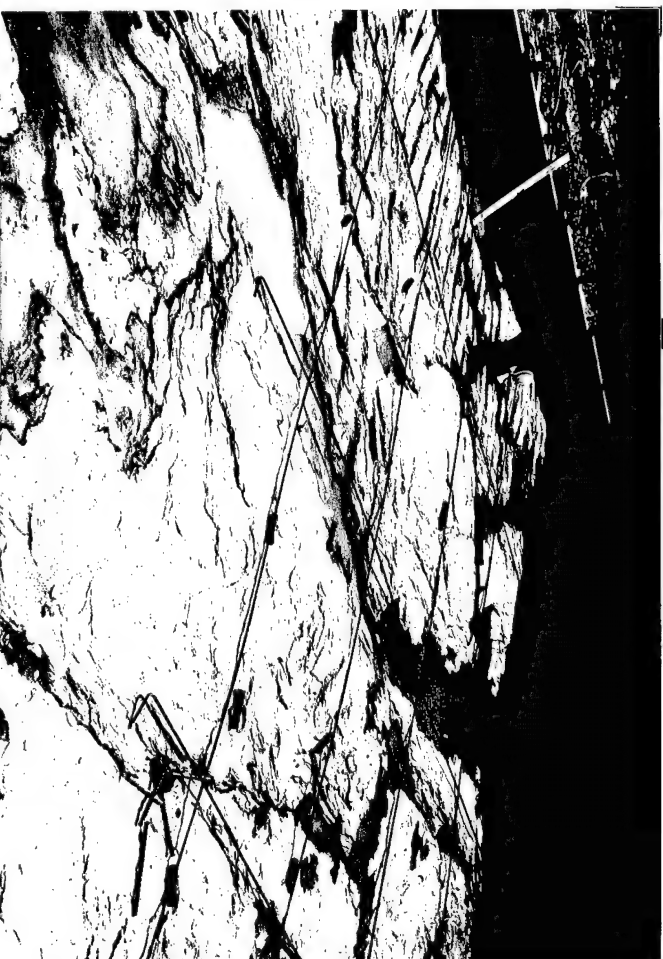
(42) R-34 Diagonal view Southwest corner

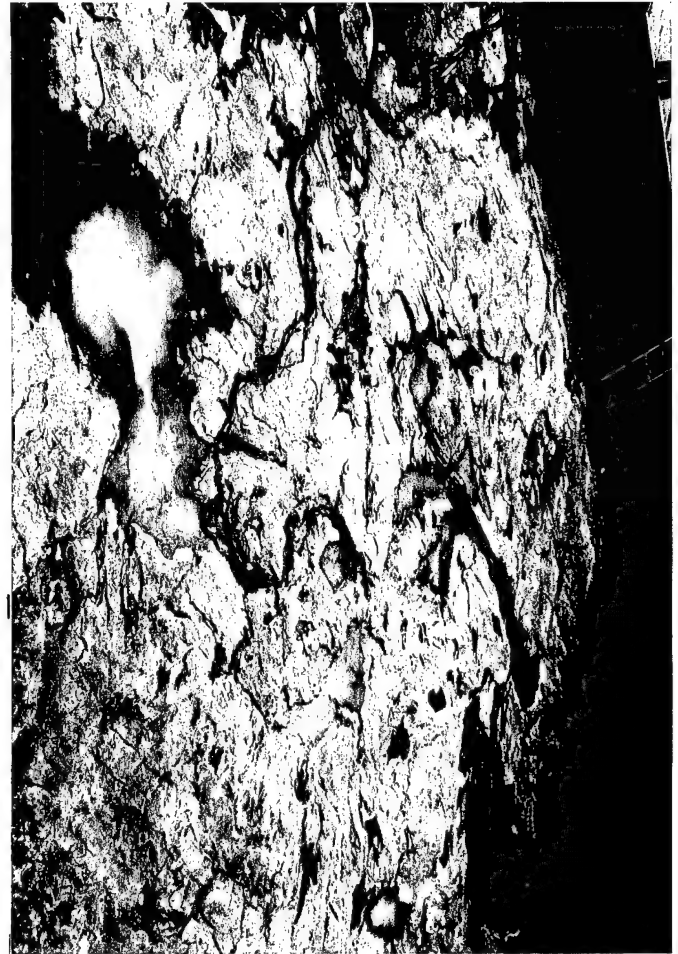
(43) R-35 Diagonal view looking Southwest

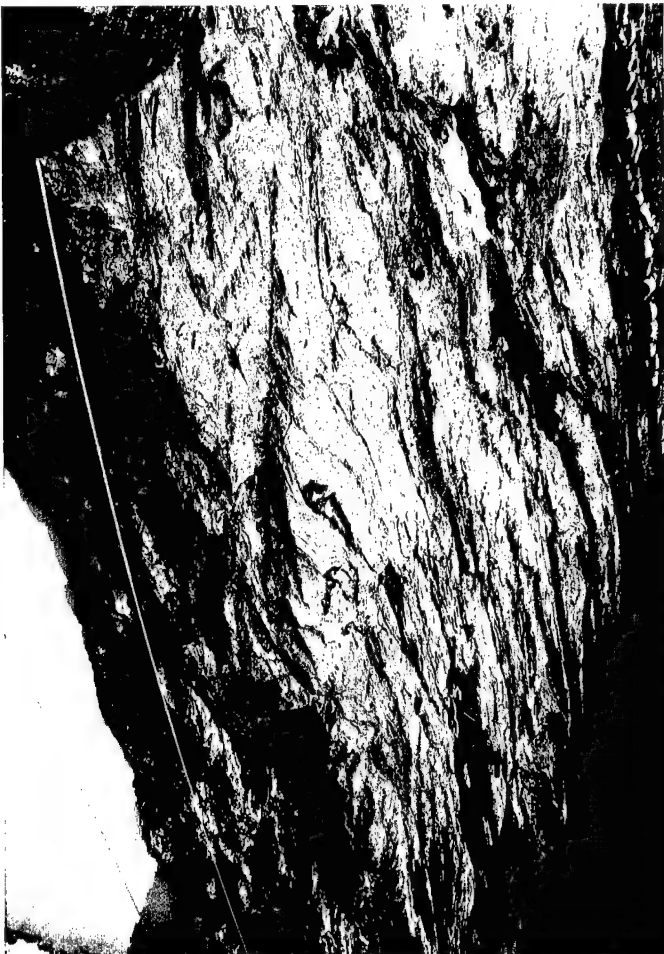
(44) R-36 Invert view Southeast corner

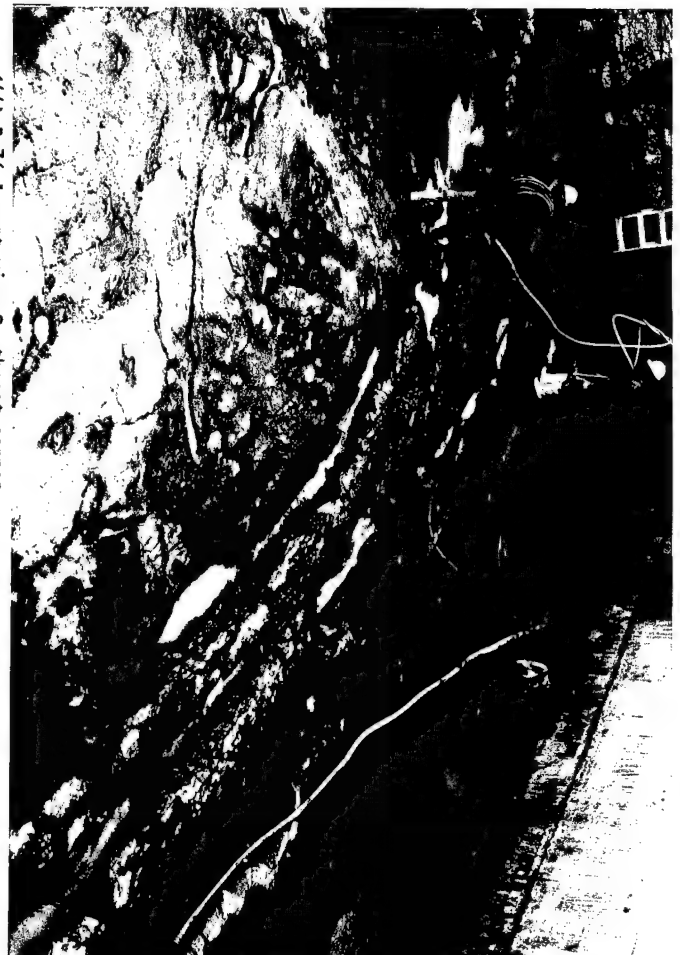
(45) R-37 Invert view looking Southwest

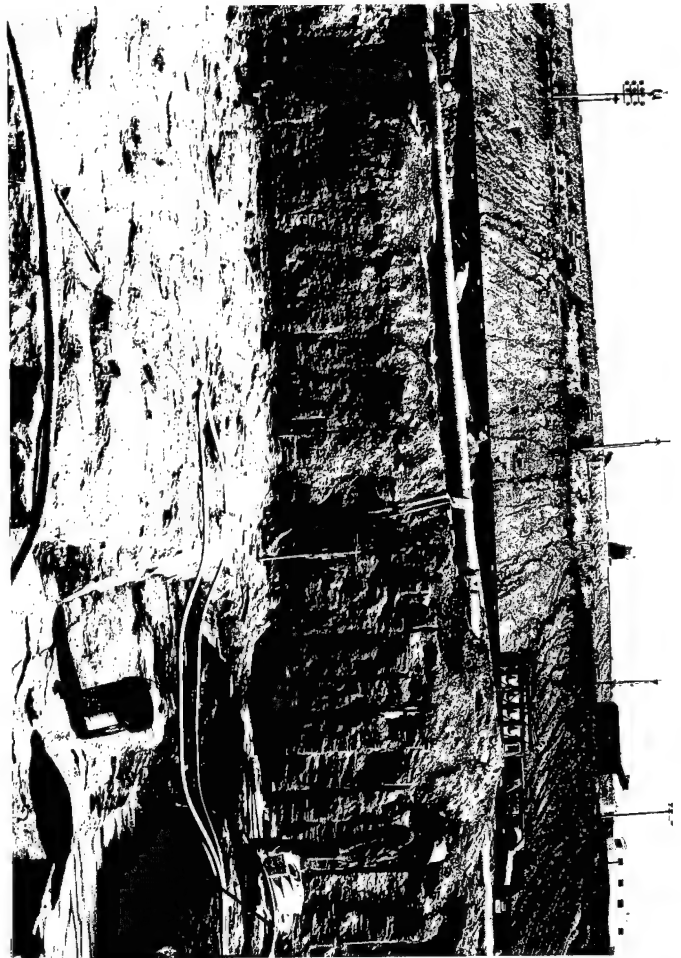
(59) R-51 Land wall Northern half

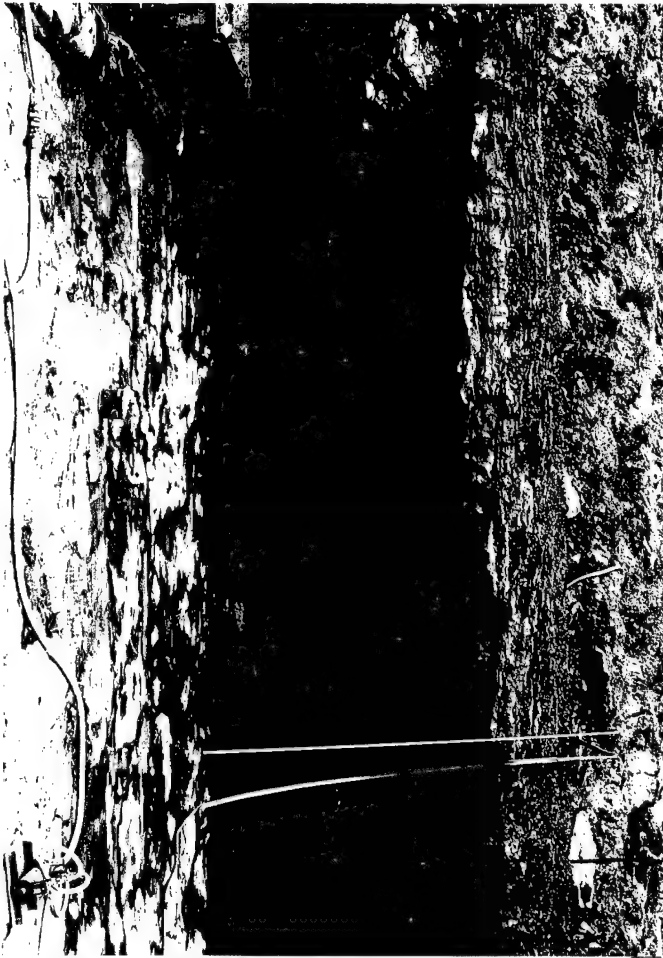
(60) R-52 Invert view of Northeast corner

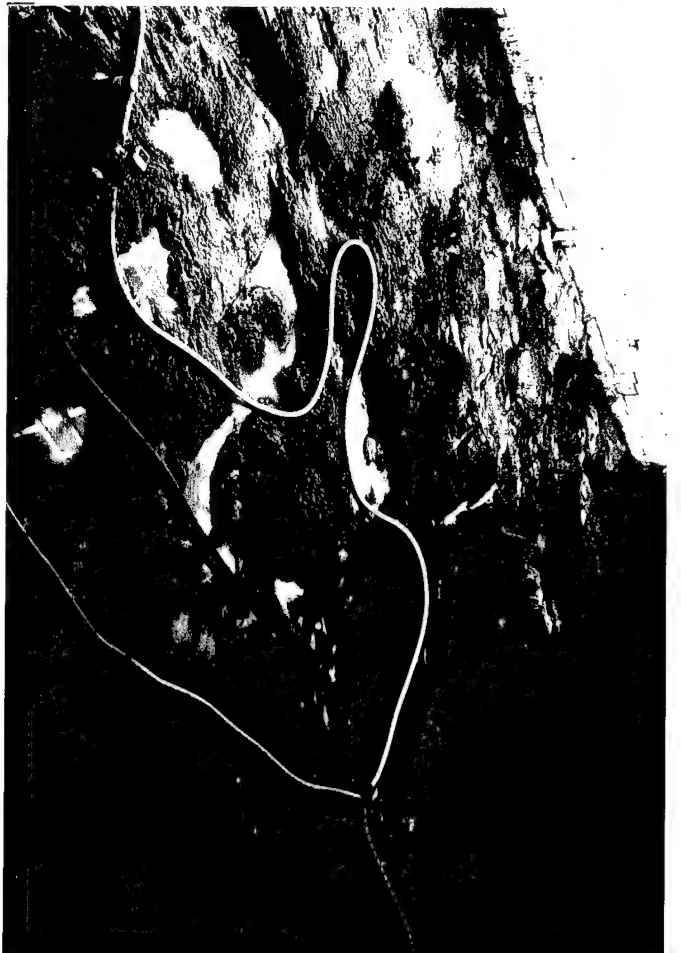
(61) R-53 West wall Southern half

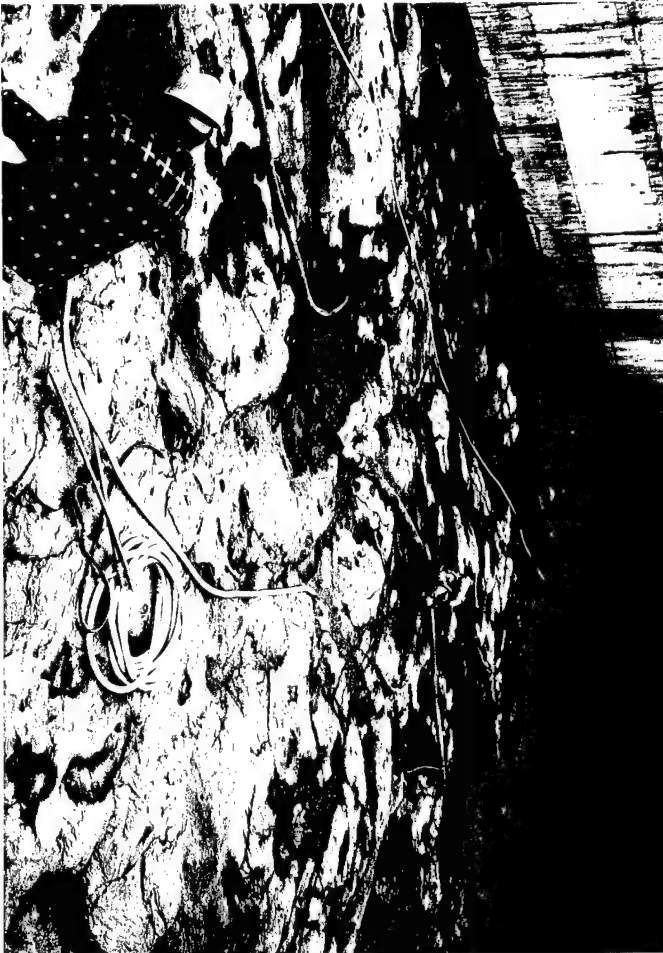
(62) R-54 Invert view of Southwest corner

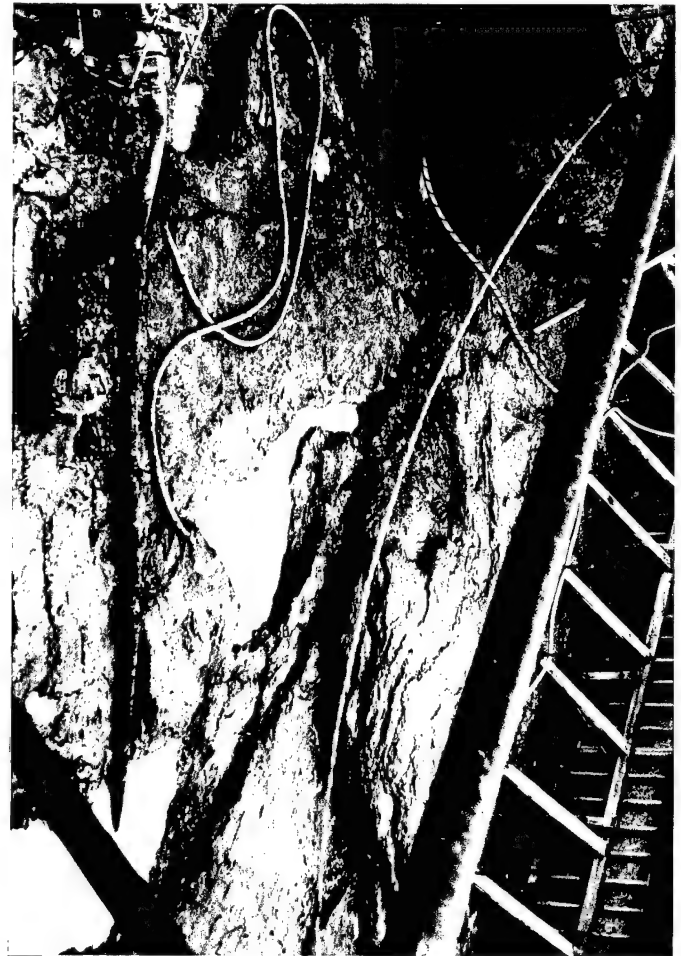
(75) R-67 Invert view of Southeast corner

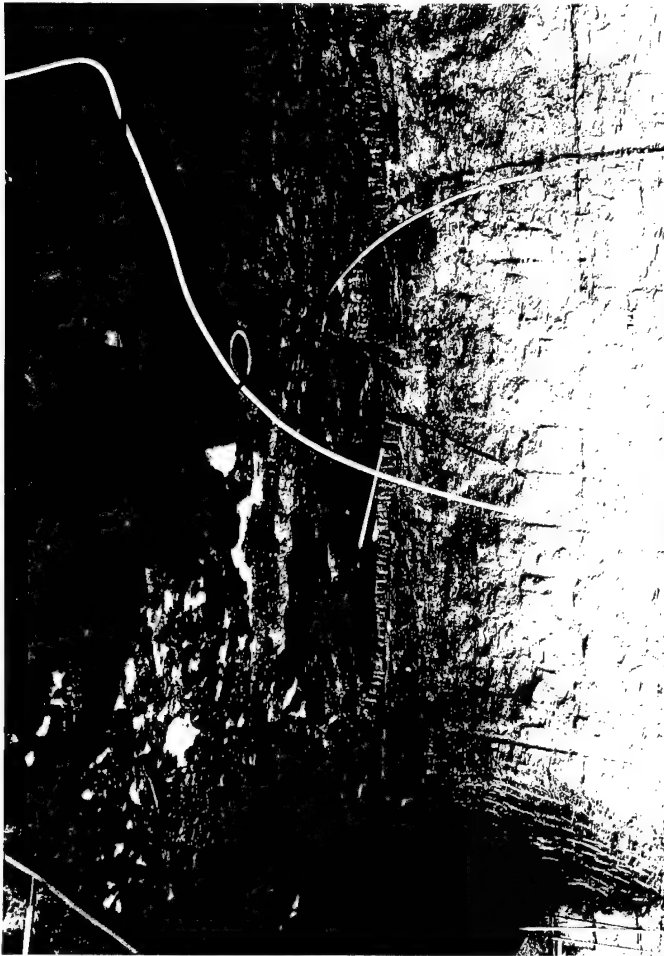
(76) R-68 Invert view of Northeast corner

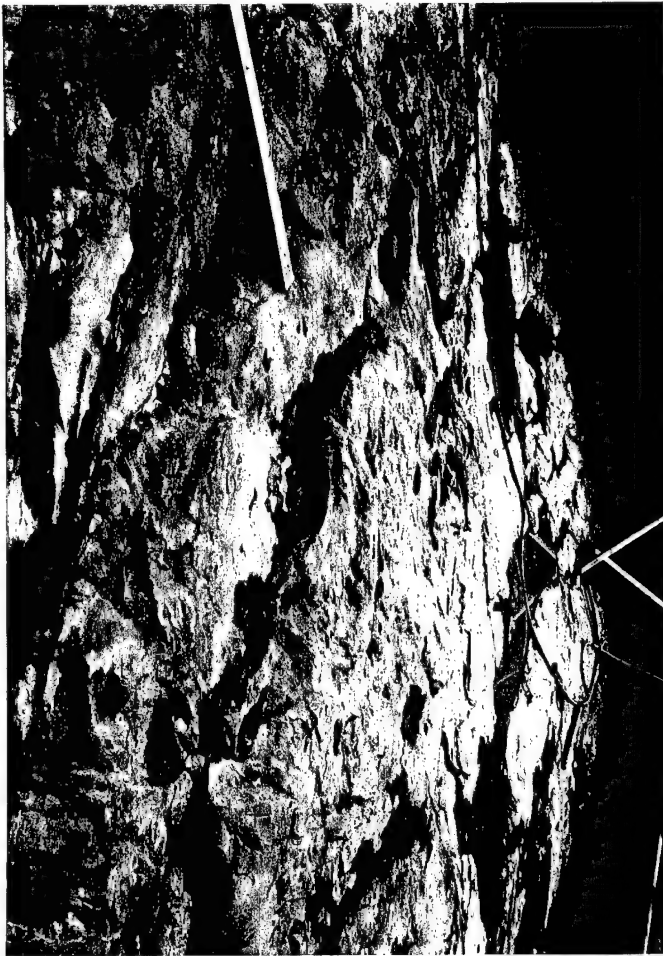
(122) M-17 View of East wall Northern half  
(124) M-19 Invert view of Northwest corner

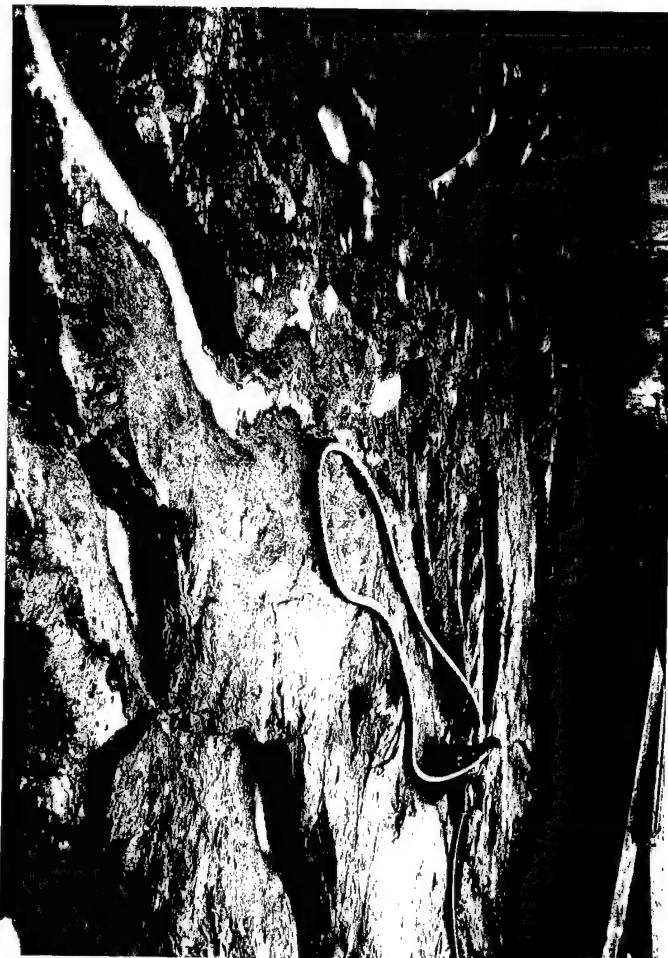
(123) M-18 Invert view of Northwest corner  
(125) M-20 Invert view of Northeast corner

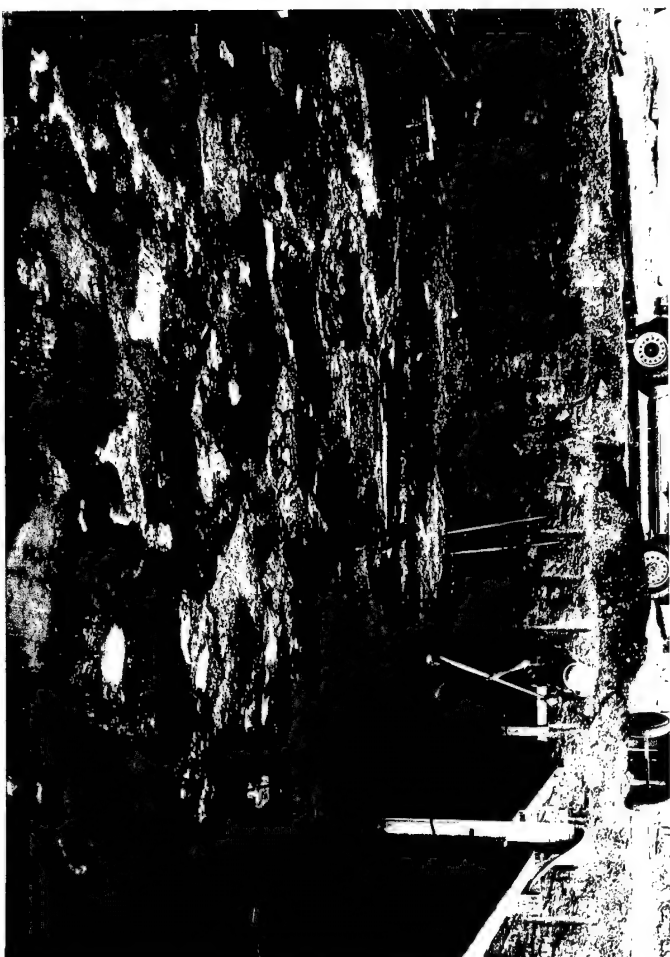
(126) M-21 View of West wall Southern half  
(128) M-23 Invert view of Northern half

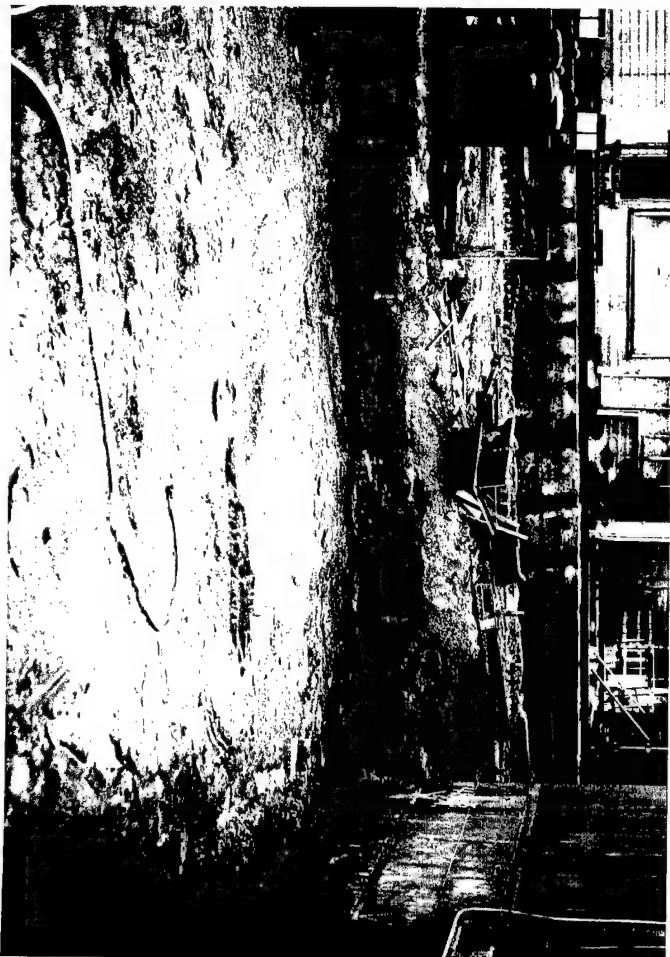
(127) M-22 View of West wall Northern half  
(129) M-24 Invert view of Northeast half

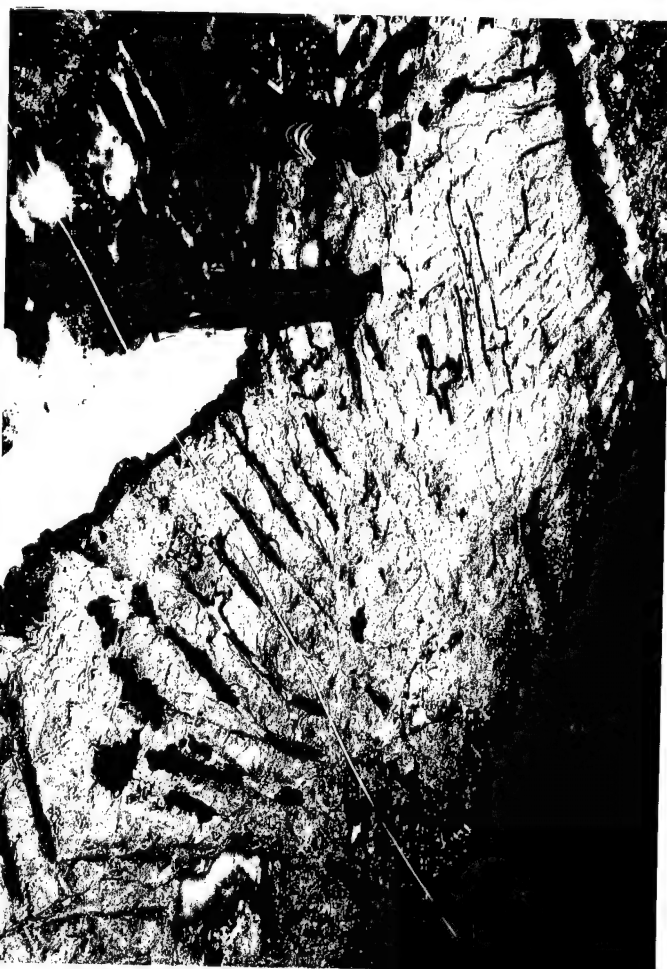
(147) M-42 Invert view of Southeast corner

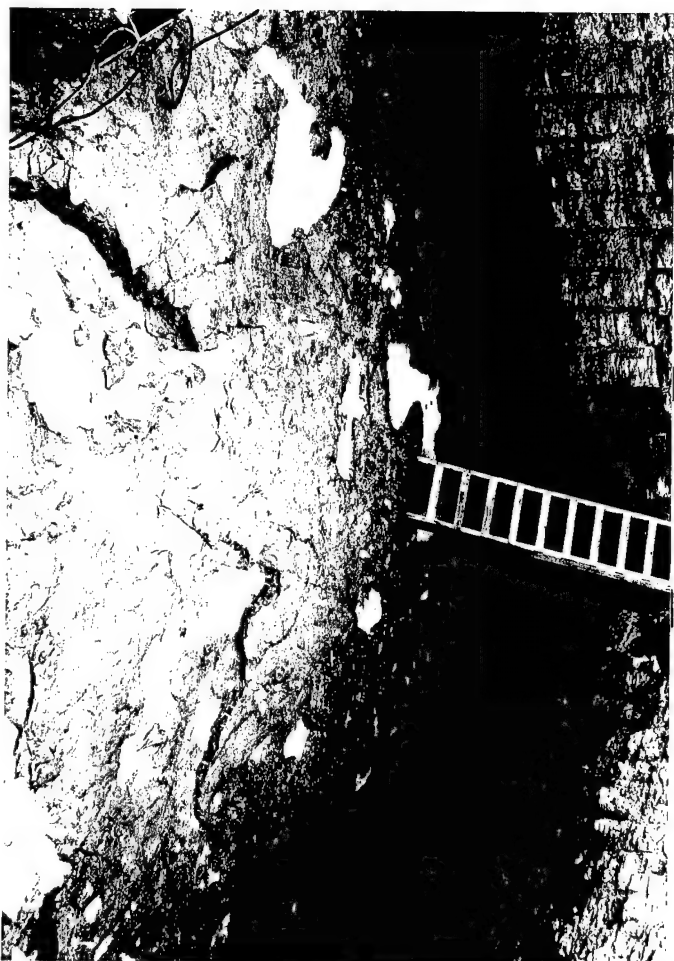
(148) M-43 Invert view of Northeast corner

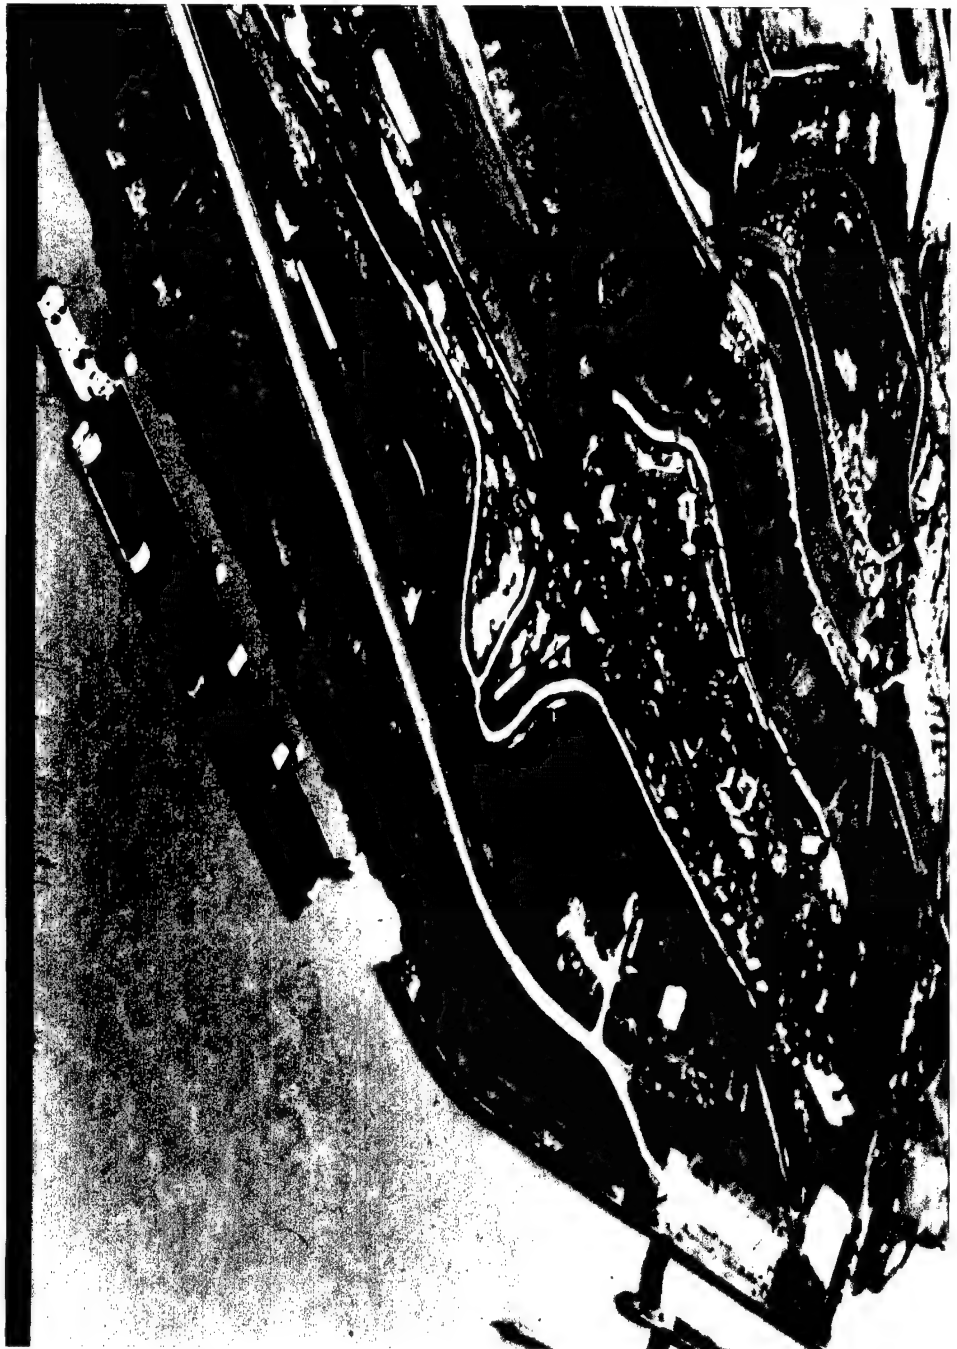
(150) February 1 1990 Aerial view of work site from Northwest

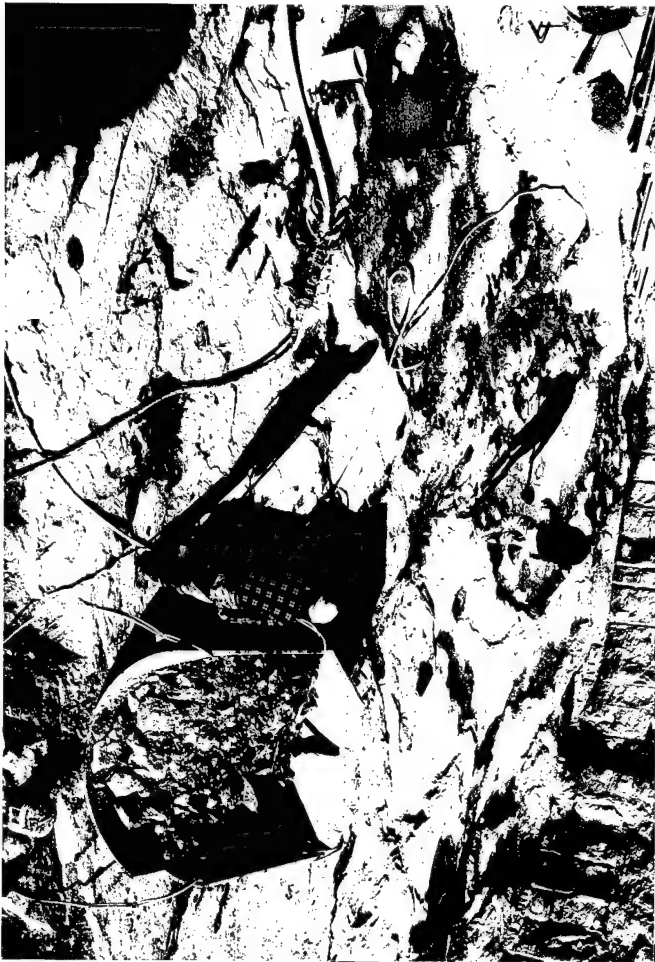
(157) L-7 Invert view of Northeast corner

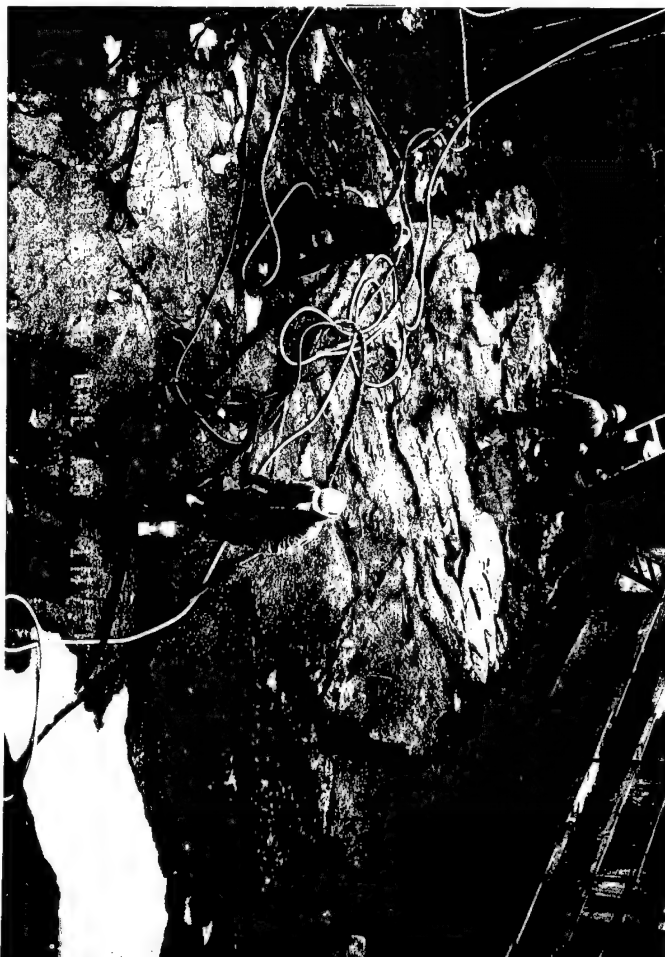
(158) L-8 Invert view of Northwest corner

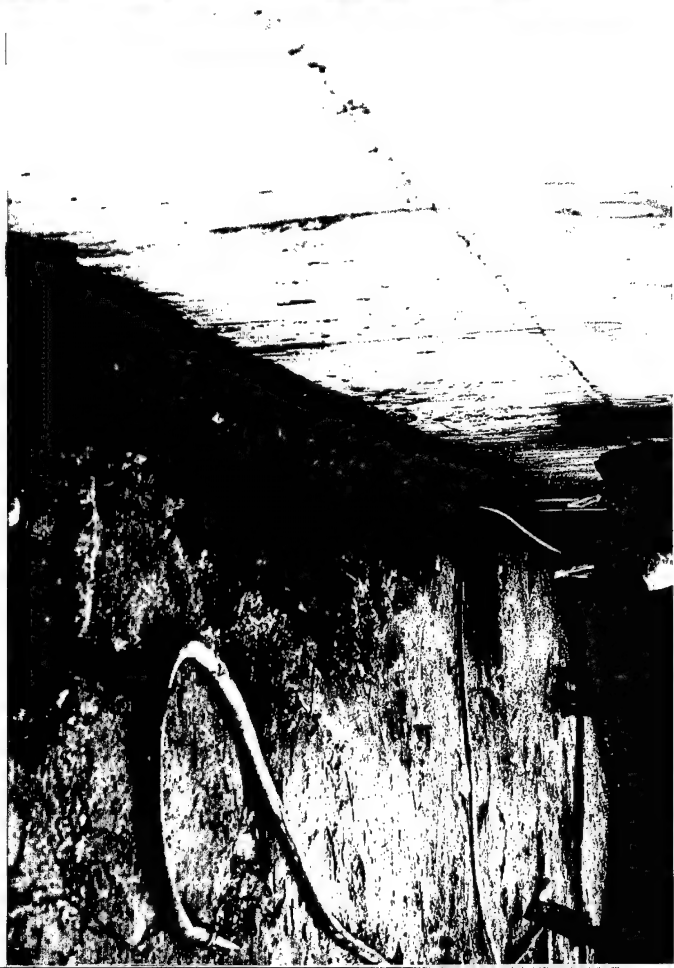
(214) R-38 Invert view looking East after repair

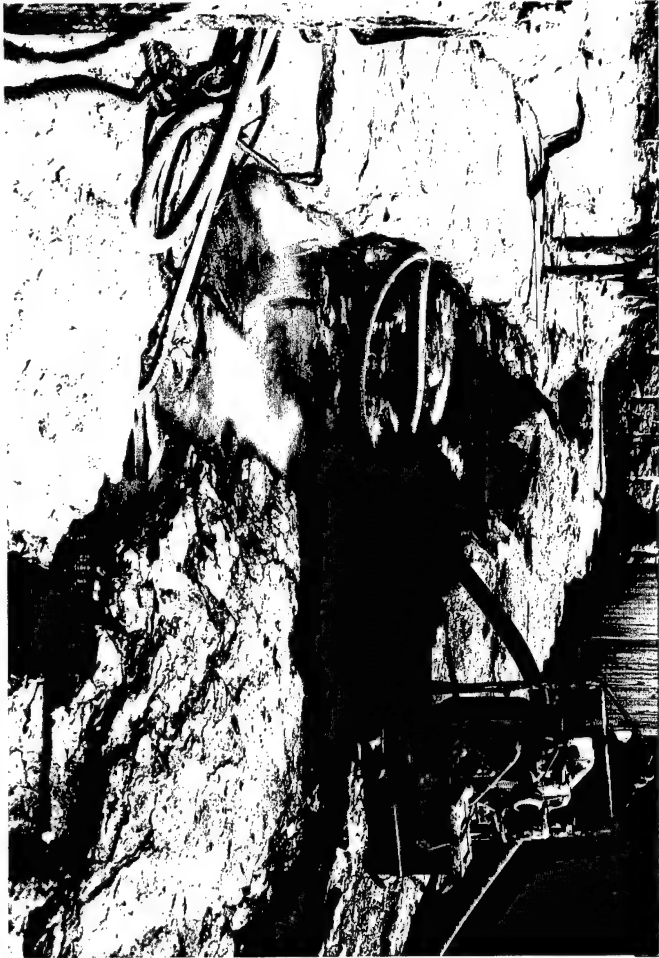
(215) R-46 Invert view looking West

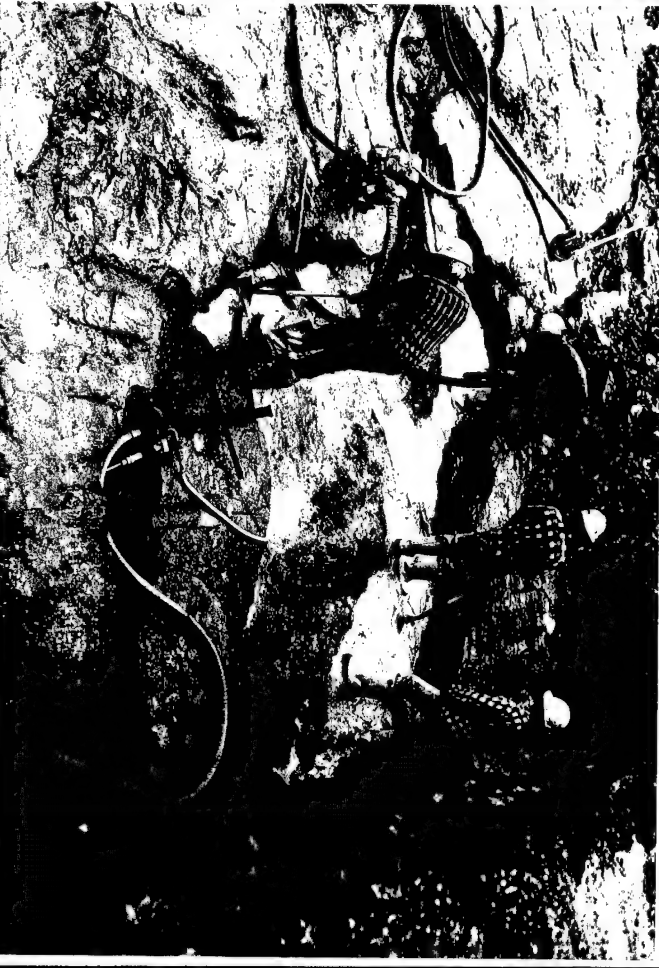
(216) R-51 Invert view looking East

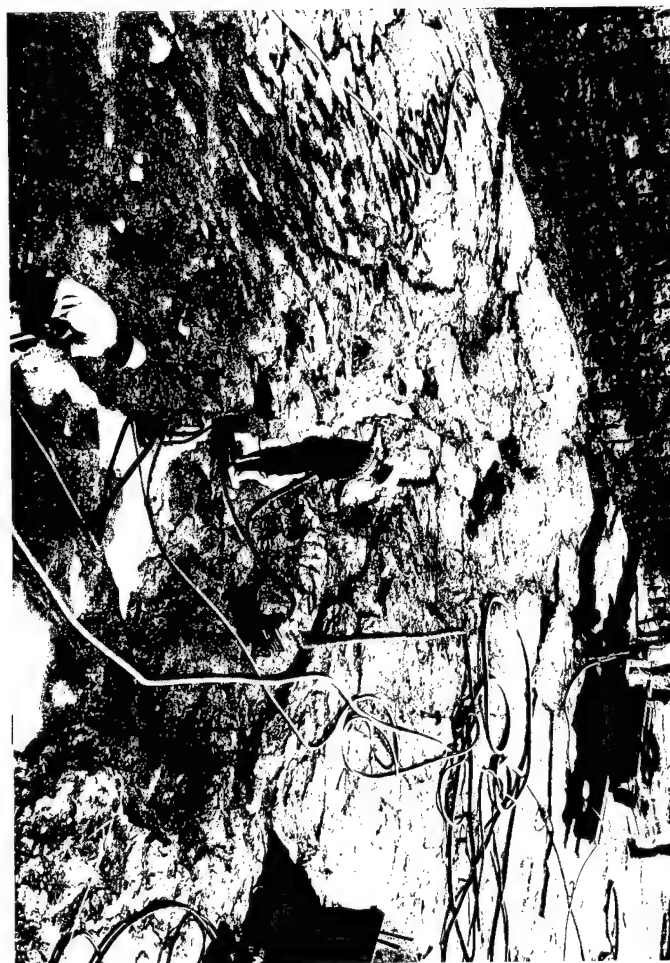
(217) R-82 Invert view looking North

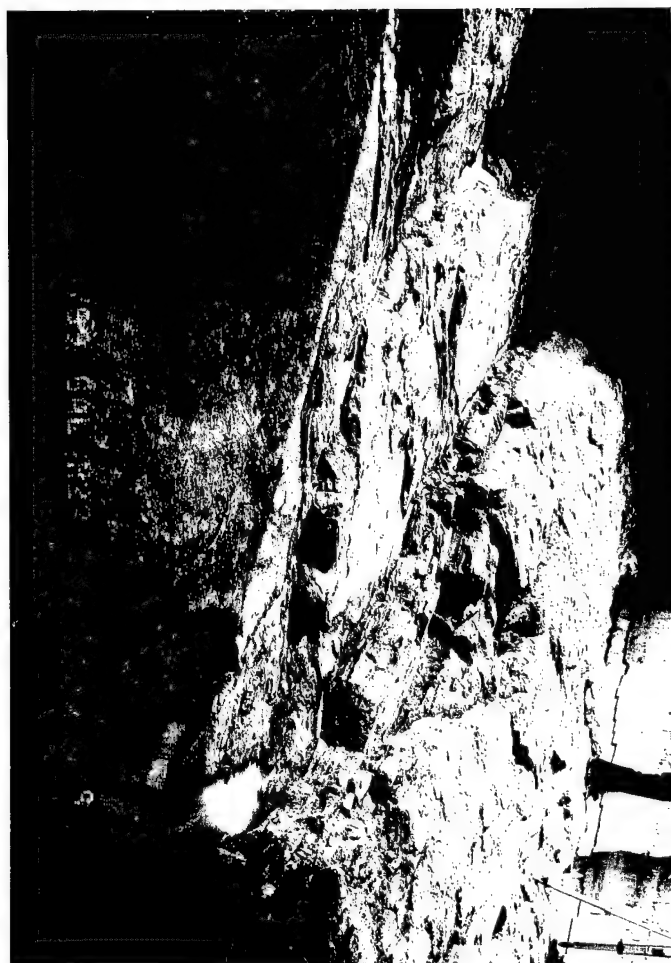
(218) R-82 Invert view looking Northwest

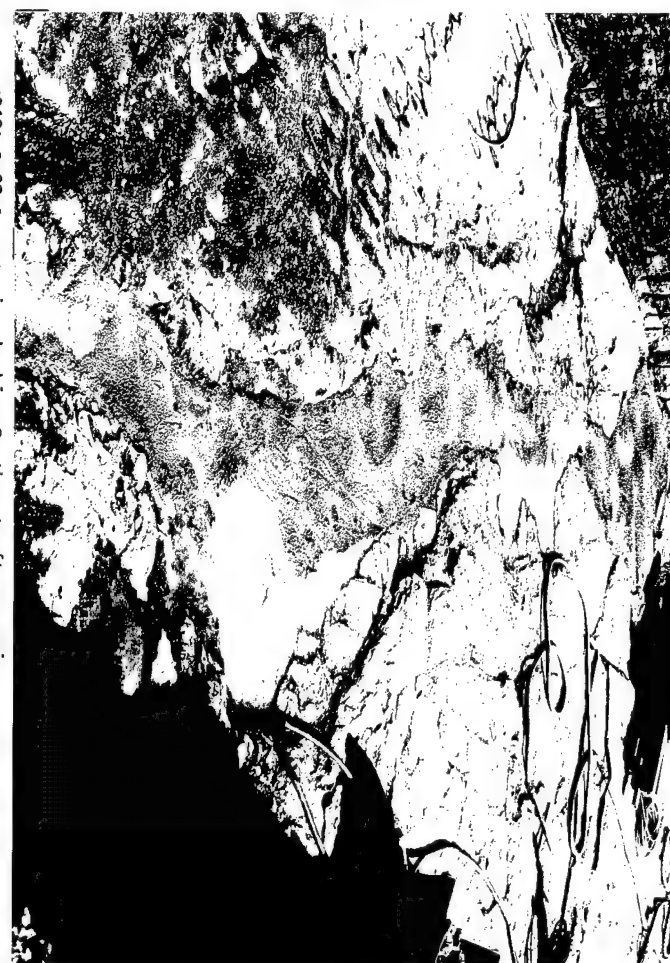
(219) R-82 Invert view looking Southeast after repair

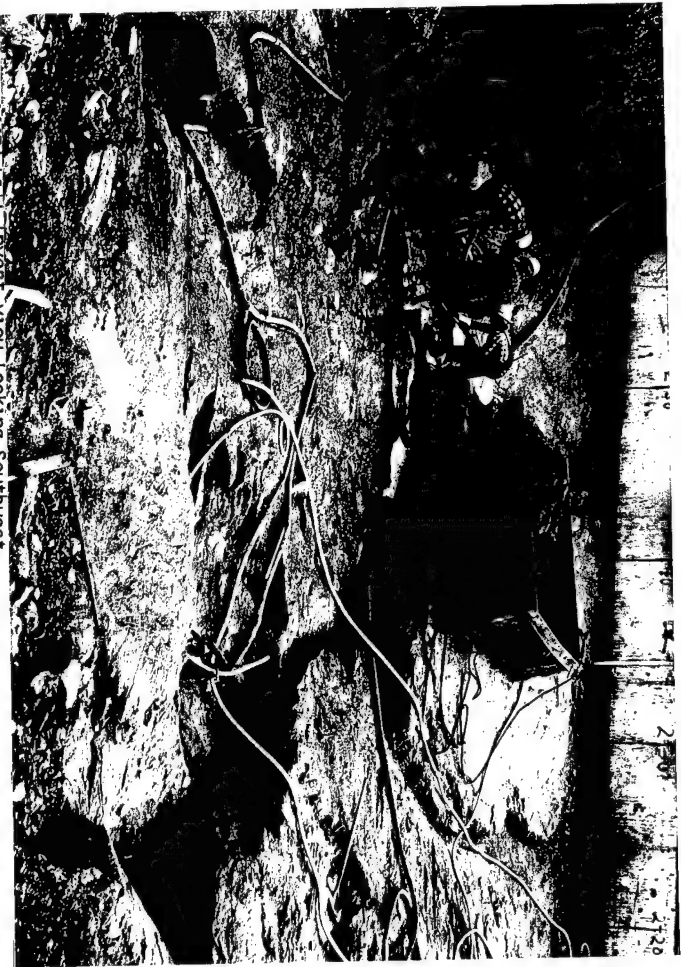
(228) L-13 Invert view looking Southwest

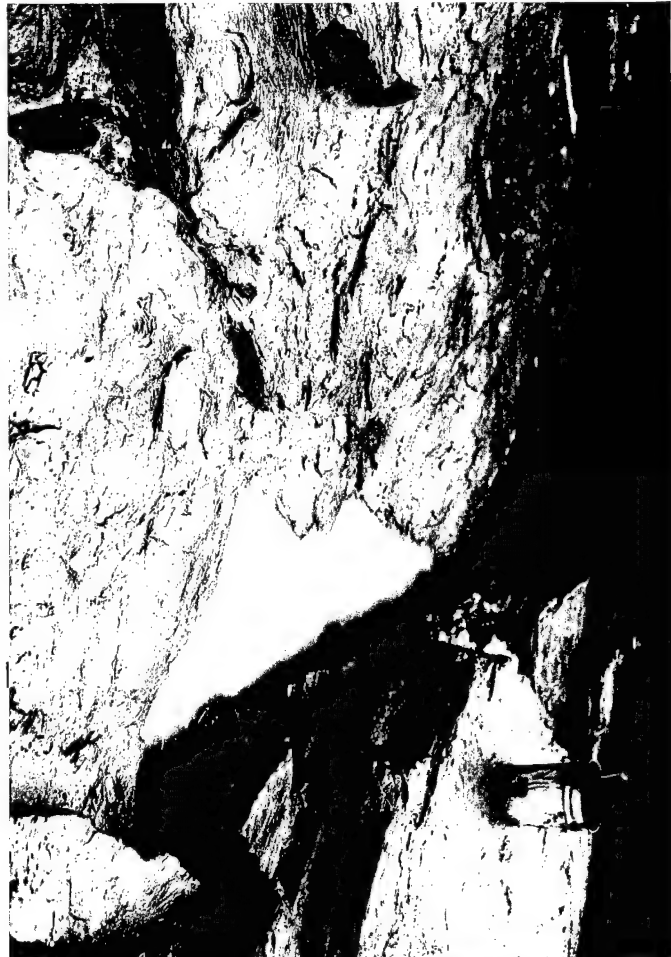
(229) L-13 Invert view looking Southeast after repair

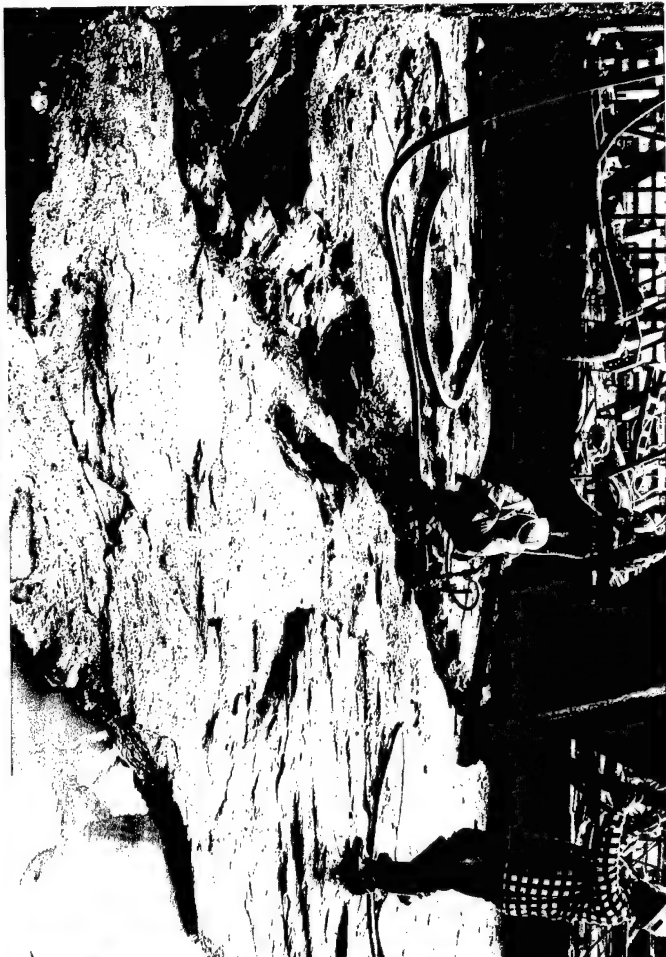
(231) L-14 Invert view looking East after repair

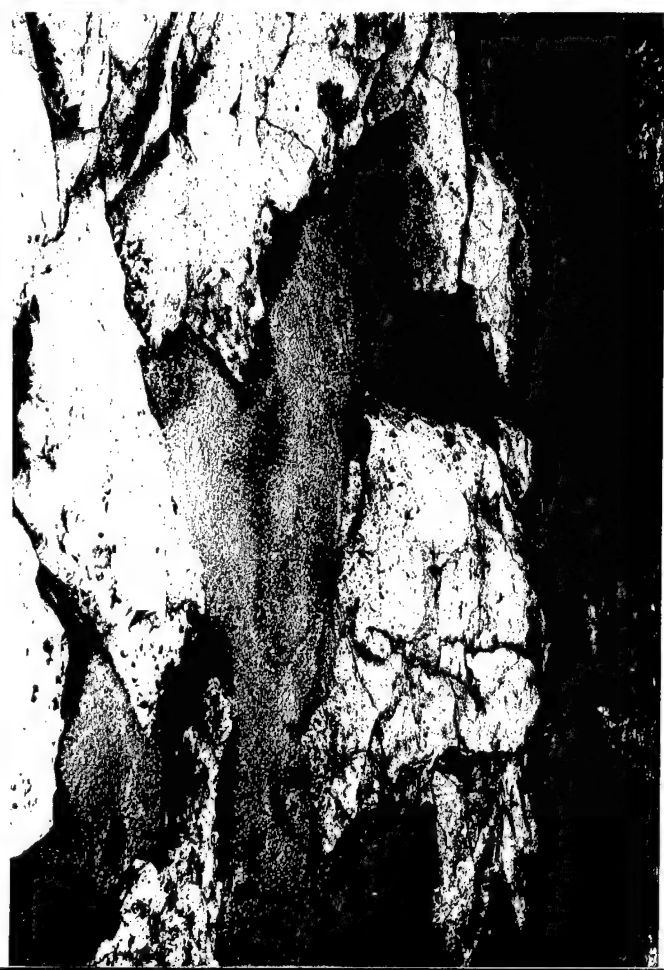
(241) MC-20 Invert view of Northwest corner after repair

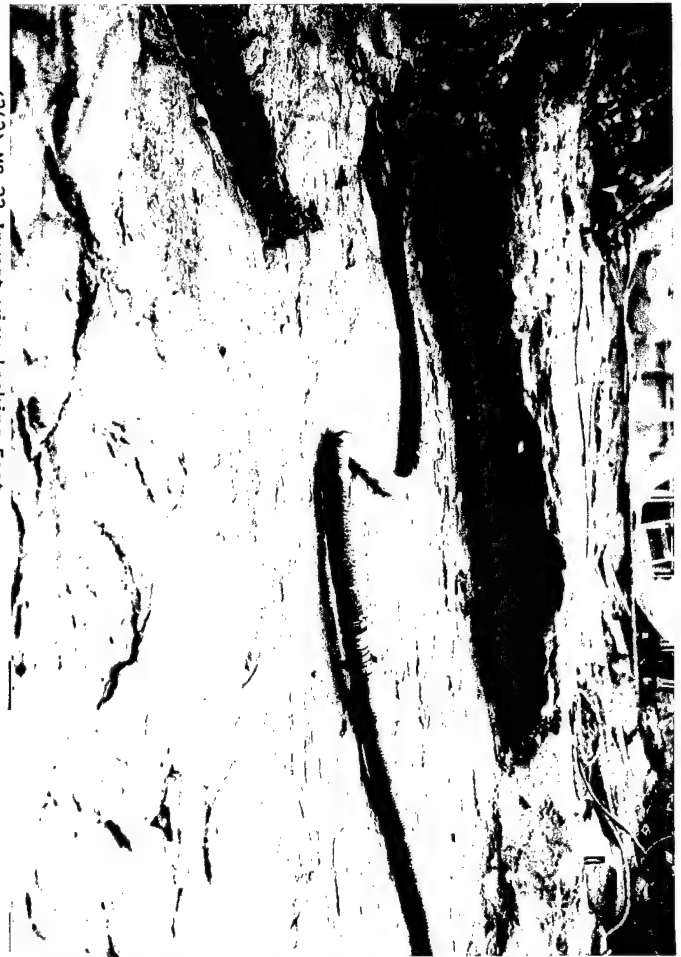
(242) MC-22 Invert view looking East  
(244) Outlet Structure Invert view looking East

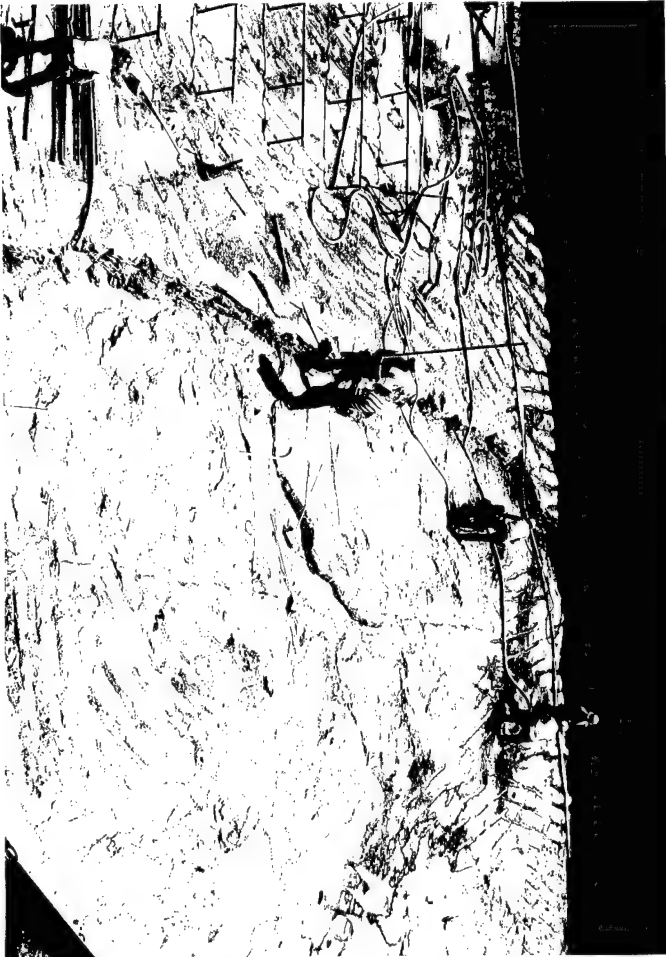
(243) MC-22 Invert view looking East after repair  
(245) Outlet Structure invert view looking East after repair

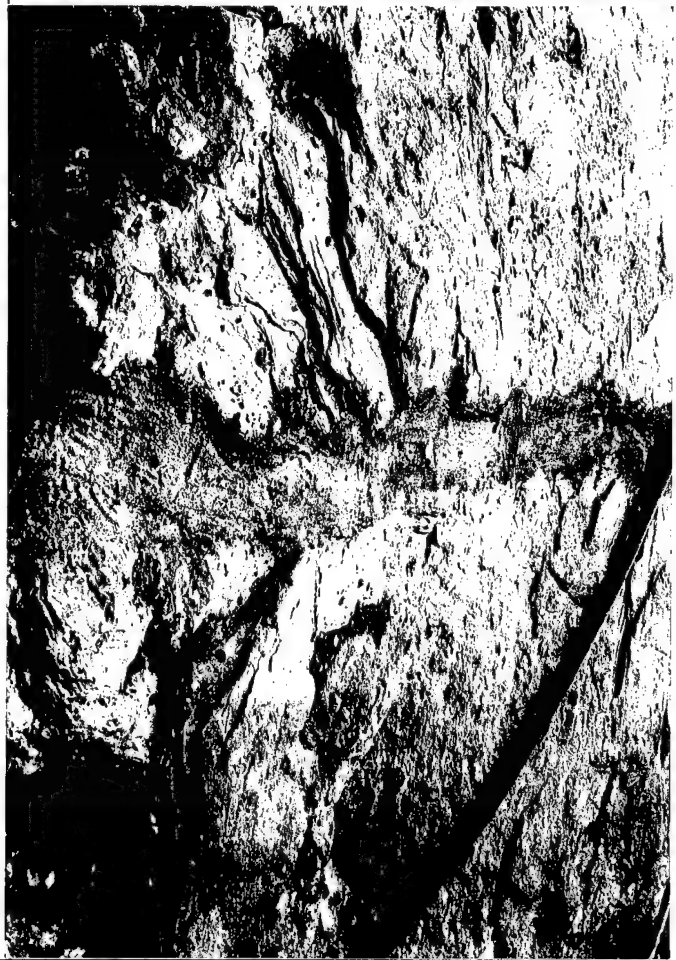
(247) L-13 Neat grout in an open joint

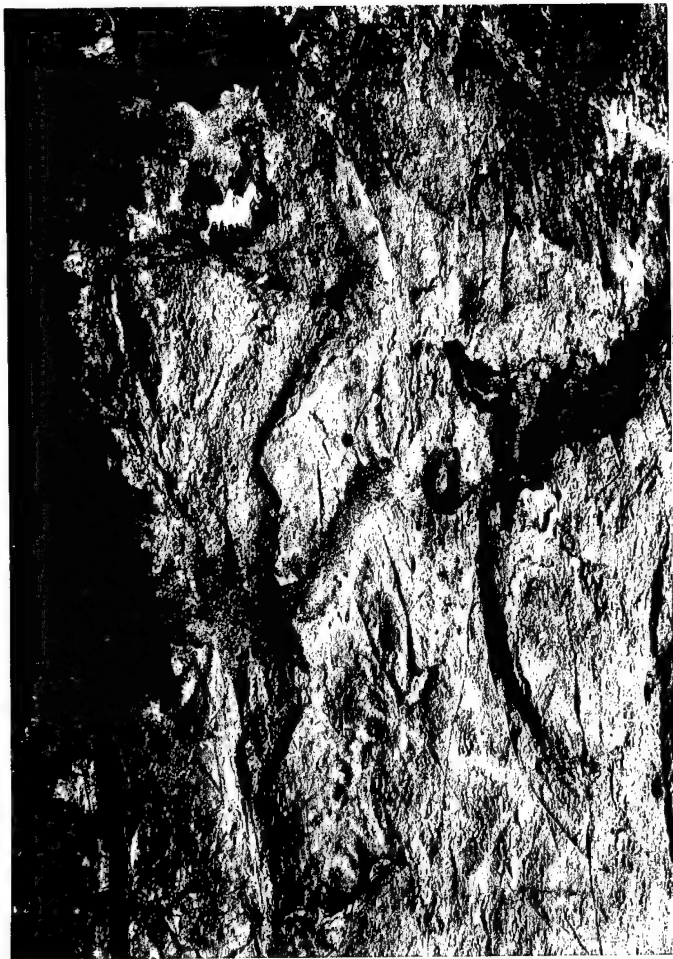
(248) L-13 Neat grout in an open joint

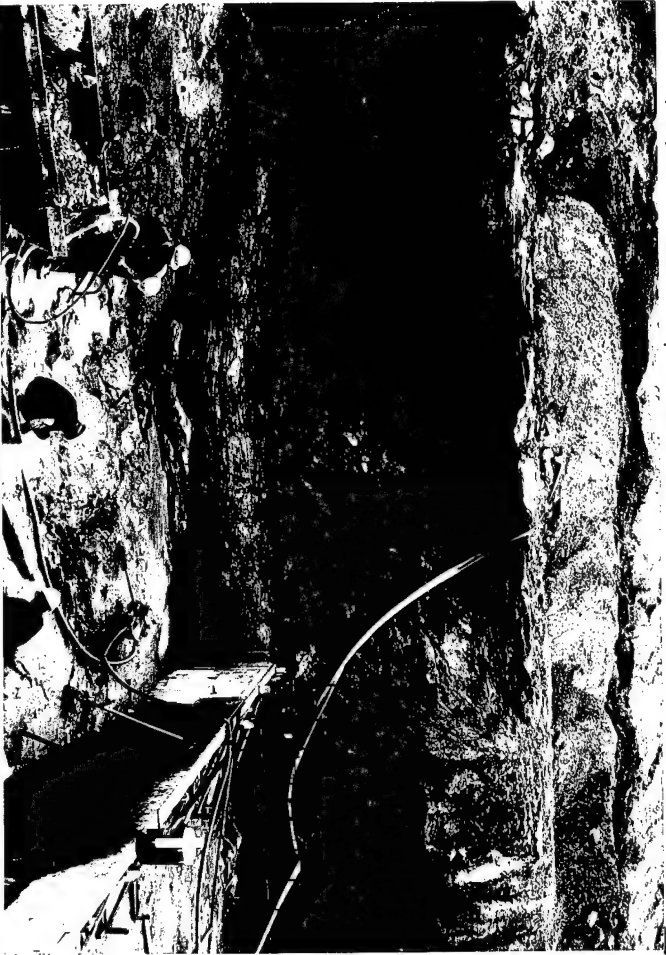
(251) R-37 View along East wall looking South
